Technical Update (July 2003)

Spring Snack vend flap modification

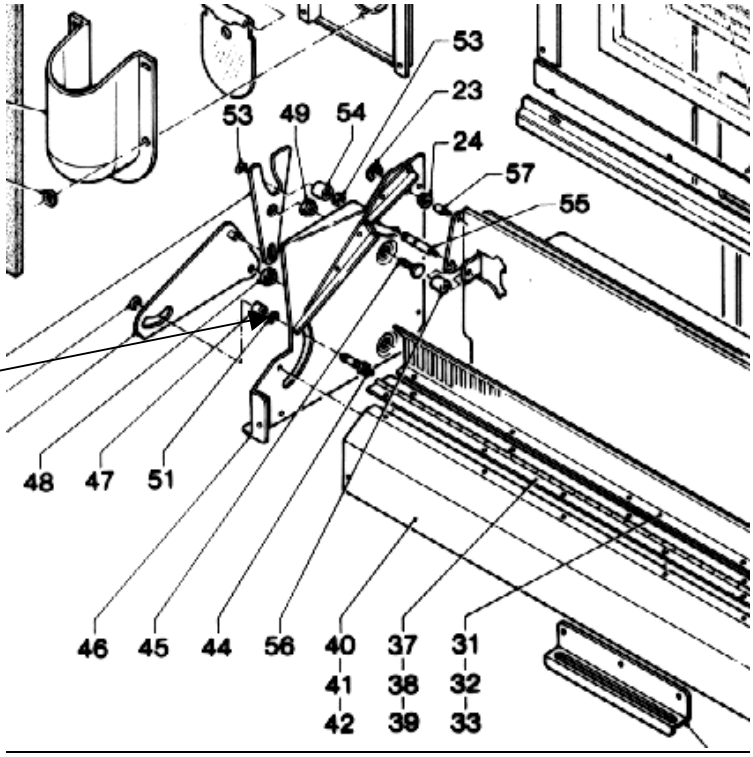
1. The mechanism for the vend flap, overrides on its mounting bracket and restricts its movement

There is nothing to stop the mechanism from overriding onto its mounting

Washer to be added here

Add a washer to the mechanism assembly, which prevents the override occurring

We can supply a washer of the correct dimensions, the part number is .
